# THREADING ON SLIP RINGS

TECHNICAL NOTE ■ STA BE 16-25 GB

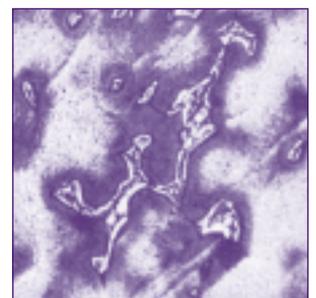
Fig. 2

- Inside porosity or blowholes due either to gas bubbles enclosed in the metal during solidification or from cracks due to a defective casting process (fig. 1).
- Dendritic structure which appears under the microscope as “fish bones” and denotes a lack of homogeneity of the solid solution (fig. 2).
- Existence of isolated crystals in the  $\alpha$  phase, generally small but with hardness higher than that of the matrix in the area in which they have grown. These crystals are rich in tin ( $\delta$  and sometimes  $\epsilon$  phase) and appear during the solidification when the cooling speed is excessive; they have not been dissolved during the annealing procedure (fig. 3).
