Investigation Of Factors Affecting The Sustainability Of Arcs Below 250V.

Abstract. Recent testing with various electrode configurations and insulating barriers suggests that 250V equipment omitted from arc flash hazard analyses has the potential for burn injury. Research into the sustainability of arcs at these voltages shows assumptions about the magnitude of these hazards need to be revised. This research enhanced the work of previous efforts by focusing on the sustainability of arcs with fault currents lower than 10kA. Gap lengths between electrodes, electrode shape, electrode material and voltage variations were studied for their effects on arc sustainability. A modified barrier design, representative of the space around panelboard bus bars was also studied.

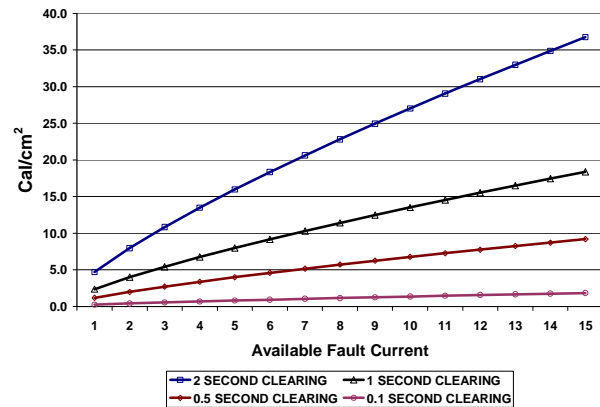
Calculations using the IEEE 1584 equations for a 208V panelboard are plotted in Fig. 1 for fault currents below 15kA. When using the upper 2-second limit suggested in section B.1.2 of IEEE 1584, incident energy calculations exceed 8 cal/cm² for available fault currents as low as 2kA. Clearing time (arc extinguishment) must be below four cycles for this entire current range to limit incident energies to below the 1.2 cal/cm² threshold where arc rated personal protection equipment (PPE) is indicated.

Fig. 1. Incident Energy Calculations for 208V Panelboards using IEEE 1584 equations.

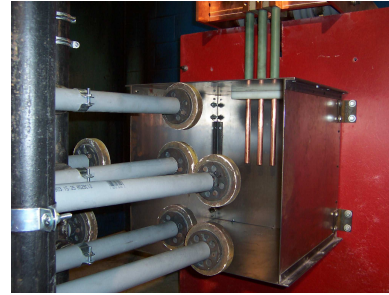
tests were run using 3 phase vertical electrodes as shown in Fig. 2 with arcs initiated on the open tips

Fig. 2. Vertical Electrode configuration

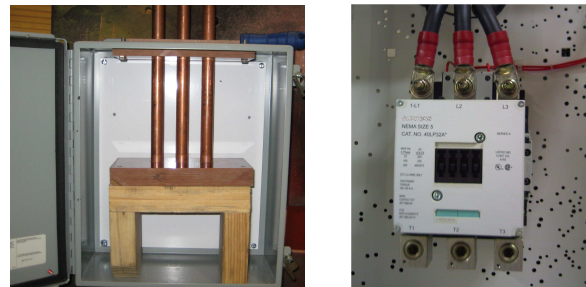
After the release of IEEE 1584, tests were performed with an insulating barrier [4] attached to the bottom of the electrodes as shown in Fig. 3. The tests for that paper examined the effect of a barrier on incident energy and arc current level as compared to 1584 equations. Similar to IEEE 1584 tests and [5], these tests used a 508mm x 508 mm x 508 mm enclosure with a 32mm gap between electrodes for 208V, 480V and 600V systems.

Fig. 3. Barrier configuration is used to simulate conductors on top fed equipment shown at right.

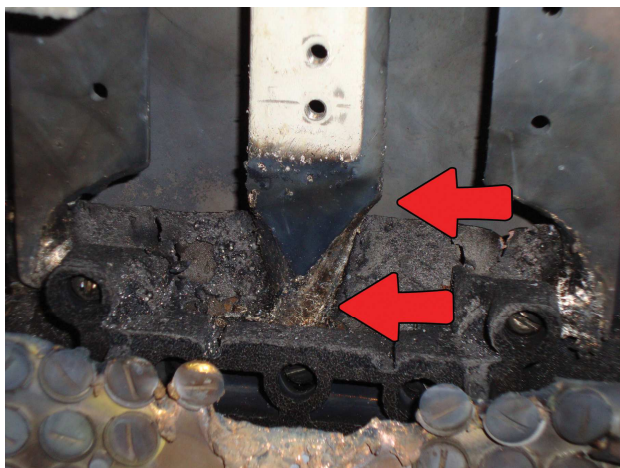
If the plasma and hot gases from an arc fault are confined in a small location, a higher degree of ionization can be maintained about all electrodes by the two remaining conducting phases. In some configurations, it may be possible for the arc to re-strike upstream from the last location of the cathode prior to the arc extinguishing. Fig. 4 is a photograph of the bus bar erosion where an arc had been established between the aluminum bus bars just above an insulating support. With the air ionized above the top arrow, it is possible for the arc to re-strike at the smaller gap. Electromagnetic forces would drive the arc back to the barrier where it would burn for 1/2 cycle. The consumption of the aluminum electrode near the insulator is similar to that of a barrier configuration and suggests that the arc resides here for most of the burning time.

Fig. 4. Erosion of aluminum busbars from panel arc fault.

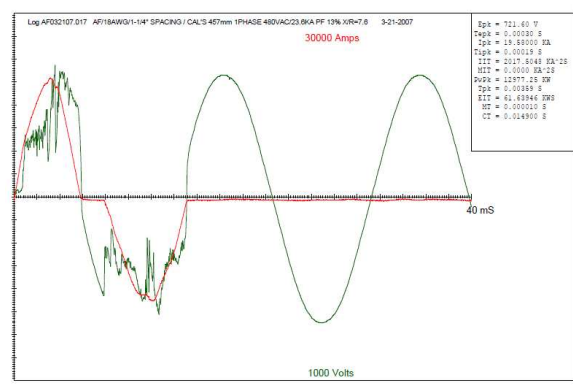
The trace shown in Fig. 5 is from a single phase vertical open tip test in a 508mm x 508mm x 508 mm steel enclosure. The test was run at 480V, 23.6 kA and a X/R of 7.6. Note that after the first zero crossing, current flow is effectively zero for 2.1 milliseconds until the system voltage recovers to -536V. This indicates that dielectric re-ignition occurred as discussed above. After the second zero crossing, the arc does not re-ignite. It is postulated that the ionized gas was driven away from the tips, rapidly de-ionizing the area between the electrodes. The voltage could not recover fast enough to cause re-ignition in the gap or the longer arc path just prior to the current zero.

Fig. 5. Trace from 480V single phase open tip test.

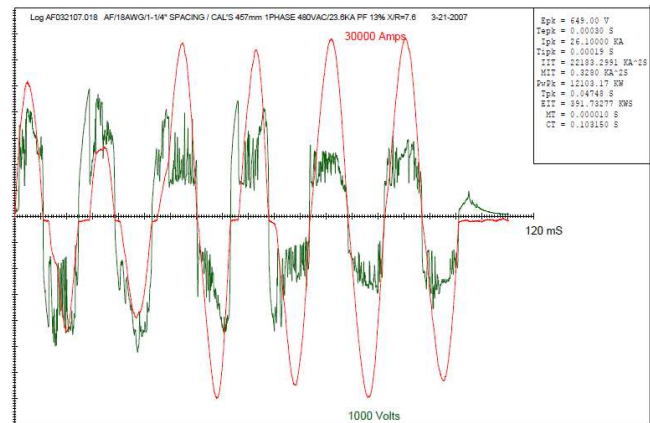
The trace shown in Fig. 6 is from a repeat of the previous single phase vertical open tip test 23.6 kA. Note that at the beginning of the 2nd cycle the traces indicate dielectric re-ignition. After the zero crossing of current the arc is extinguished and current flow is effectively zero. The voltage recovers to 616V, the arc re-establishes and the arc burning voltage is determined by the path and current magnitude. At the beginning of the 3rd cycle, re-ignition occurs at a lower voltage and the current reaches a higher level for subsequent peaks. By the start of the sixth cycle the recovery voltage is only 172V and current flow resumes almost immediately after the zero crossing. It appears that a different re-ignition mechanism has occurred, most likely due to the increasing ionization within the large enclosures.

Fig. 6. Trace from 480V single phase open tip test.

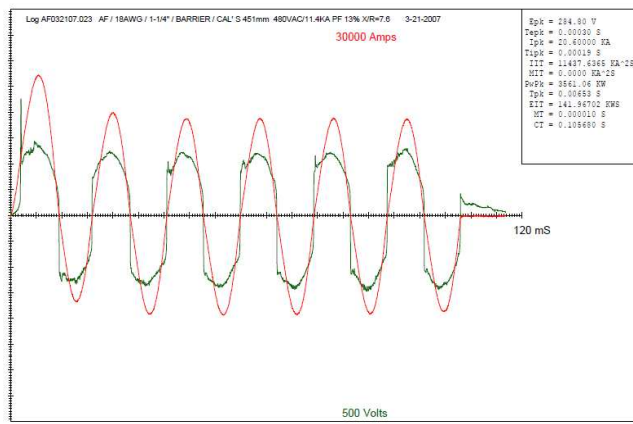
The trace shown in Fig. 7 is from a single phase vertical electrode configuration terminated in an insulated barrier. This test was performed at 480V, 11.4 kA and X/R of 7.6. Note that after the beginning of the event, when the trigger wire melted, the current always resumes almost immediately after the zero crossings, suggesting thermal re-ignition. Highly ionized gas between the electrodes may play a bigger role with this barrier configuration than the open tip configuration and may help to explain the sustained arcs at 208V and low fault currents. Pyrolysis of the insulating barrier may also contribute to sustainability of the arc.

Fig. 7. Trace from 480V single phase barrier test

Tests run at 250V showed even more dramatic effects on arc sustainability. The trace shown in Fig. 14 is from a single phase vertical electrode configuration terminated in an insulated barrier with a gap of 19mm. This test was performed at 250V, 4kA and X/R of 1.6. Note that after the trigger wire melted the arc never extinguished until the station breaker opened. Arc re-ignition after each zero crossing is similar to that of Fig. 7 for most cycles.

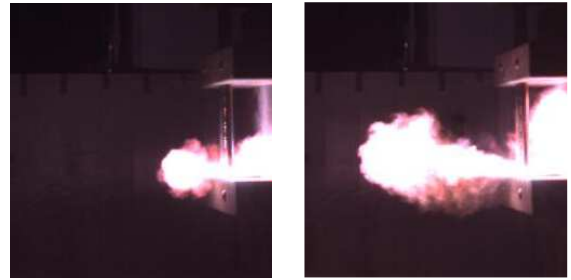
One characteristic of the barrier configuration is the ability to sustain arcs at lower available fault currents. Fig. 8 shows 2 frames from a high speed video sequence of an ‘open-air’ barrier test at

208V. As discussed in [4], the plasma flow from this configuration is along the plane of the barrier and perpendicular to the plane of the electrodes.

Fig. 8. 208V barrier test in open air – 2ms and 6ms into event.

Since this test set-up has a back panel 4” behind the electrodes, the plasma flow away from the rear of the barrier is reflected back between the electrodes. Once an arcing condition is established in an enclosure, this should have the effect of ensuring that the gases between the conductors to the electrodes are more highly ionized than with the open tip configuration, where the ionized gases are driven away from the electrodes. Re-ignition can occur along a much shorter path and require a lower recovery voltage for re-ignition. As the arcing progresses, greater ionization will make it easier for re-strikes to occur anywhere along the length of the conductors above the barrier.

The higher incident energies of the barrier configuration can be attributed to the outward plasma flow shown in Fig. 8 and described in [4]. The lower incident energy from the chamber configuration can be attributed to the upward deflection of the horizontal plasma flow by the front barrier as shown in Fig. 18. The greater distance between the conducting channel and the calorimeters allows the plasma cloud to cool before reaching the calorimeters.

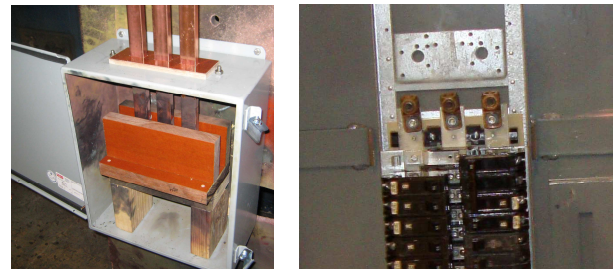
To simulate the space around the bus bars behind molded case circuit breakers in panelboards, a modified barrier arrangement, shown in Fig. 9, was used. A 203 mm x 25mm x 76mm block of phenolic material was attached along the front and back of the insulated barrier used in prior testing. Investigations were made to determine whether the front barrier diverted the outward flow of plasma upward and increased ionization levels between electrodes during the arc event with the lower fault currents. The results of these tests are reported as the chamber configuration.

Fig. 9. Chamber Configuration. This is intended to simulate the tight space behind the breakers and around the bus bars in the panelboard shown at right.

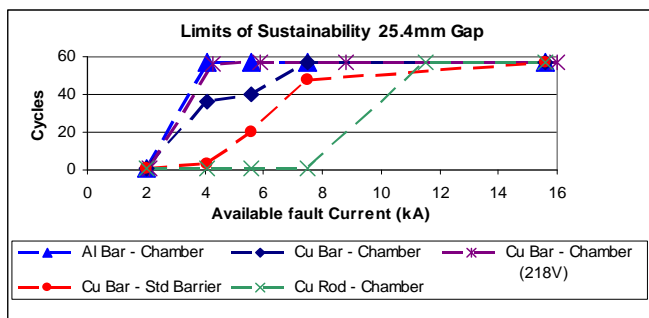
Each configuration was tested with progressively lower I_{BF} until they failed to sustain arcs for at least three cycles. The station breaker was set to limit each event near to 1 second. Fig. 10 shows the longest duration arcs obtained with configurations using 25.4mm gaps and various test variables. From the limited number of scouting tests it appears that the abovementioned factors are significant in determining arc sustainability for I_{BF} below 10kA. These test findings are discussed in the sections below. In the plots of sustainability, the data points indicate the longest duration observed. The lines between the data points are drawn for clarity and do not reflect results for values between the test currents.

Fig. 10. Longest duration arcs obtained during scouting tests.

electrodes. As noted earlier higher electric fields at the sharp edges likely aided arc sustainability. See Fig. 10 for a comparison of the number of cycles sustained for the 208V tests with 19mm rods and the bus bars performed with the chamber configuration at 25.4mm gap.

Effects of Voltage. Minor changes in voltage had a dramatic effect on arc sustainability for some low fault currents used during these scouting tests as shown in Fig. 10. For the 218V tests the I_{BF} was 5% higher than the 208V tests. At higher test currents, the influences of small voltages appeared to have minimal effects on sustainability, power transfer into the arc and the magnitude of the arcing current.

Effects of Aluminum Electrodes. The change to aluminum bus bar had a dramatic effect on arc sustainability for the current levels used during these scouting tests as shown in Fig. 10. At higher currents, arc sustainability appeared similar to copper.

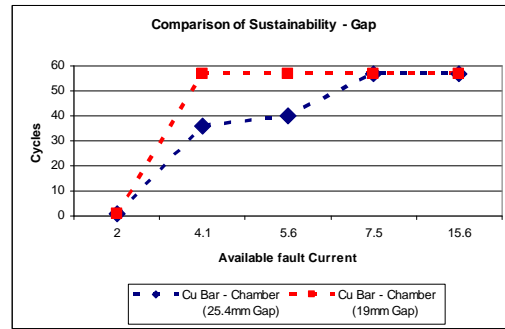
Effect of gap. Unlike the open tip configuration, the gap width is a critical variable in sustaining current flow during a low current arcing event with both the barrier and chamber configurations. At higher currents, arcs were easily sustained for the gaps tested; the size of the gap affected the amount of power transferred into the arc and the magnitude of the arcing current. Fig. 11 shows a comparison of the number of cycles sustained for the 208V tests performed with

the chamber configuration at 0.75" and 1.0" gap spacing. Notice the difference in arc duration for the 4.1kA and 5.6kA tests.

Fig. 11. Results of chamber configuration tests at 208V.

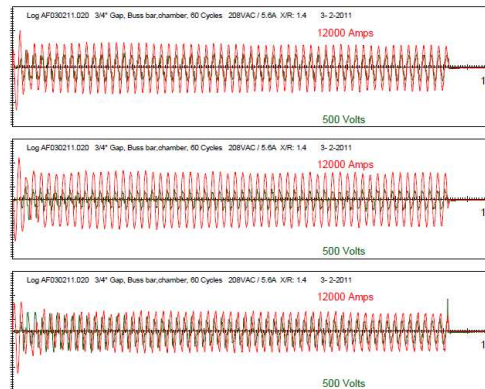
The test duration for both tests was 57 cycles. A comparison of current waveforms is shown in Fig.12. At 19mm gap and I_{BF} of 5.6kA, the arc is established when the trigger wire melts and maintains current flow through the arc for the entire test duration. With a 25.4mm gap the arc quickly extinguishes but restrikes later in the test at a low level of arc current. Approximately 18 cycles after the re-strike, the arc currents in all 3 phases look very stable; B phase current is about 10% lower than the test with the 19mm gap. Similar performances occurred with other test configurations.

Fig. 12a Chamber test at 208V, 5.6kA and 19mm gap.

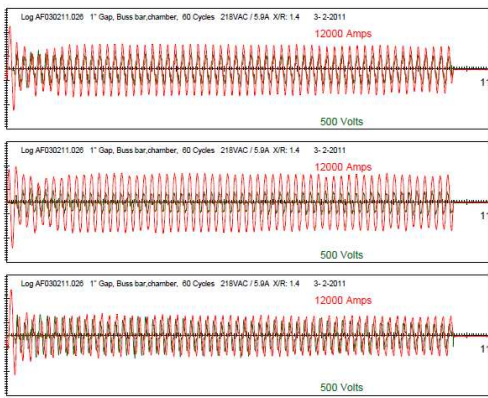
Fig.13 shows results of a 218V test tests performed with the chamber configuration at 25.4mm gap spacing and I_{BF} of 5.9 kA. The arc, initiated when the trigger wire melts, becomes firmly established in the next two cycles and maintains current flow through the arc for the entire test duration. Arc current levels are relatively stable and a slightly higher percentage of I_{BF} than the 208V test shown in Fig.12b.

Fig. 13 Chamber test at 218V, 5.9kA and 25.4 mm gap.

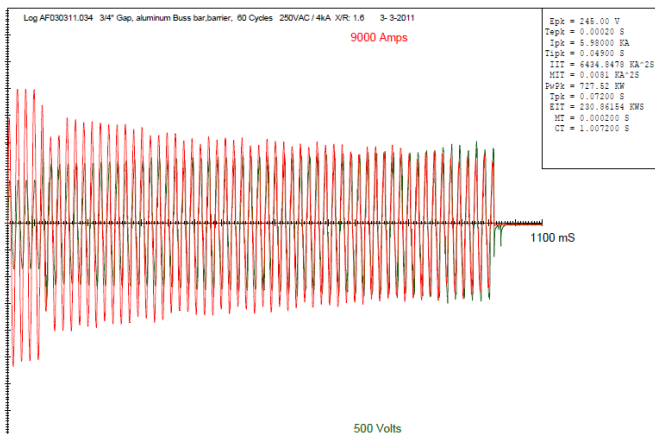
Fig. 14. Traces from 250V, 4kA single phase test barrier test with 19mm gap.

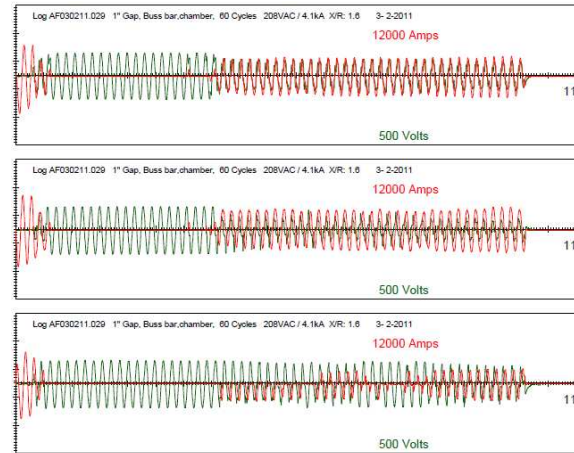
Comparing the current waveforms shown in Fig. 15 for the chamber tests at 4.1kA, it appears that aluminum electrodes help facilitate a more stable arc. With copper bus bar, the arc quickly self extinguished but re-struck several cycles later. C phase current is intermittent throughout the subsequent arcing period. Ionized gases from the arcing between A phase and B phase are likely responsible for the re-strikes of C phase during this period. With aluminum bus bars, the arc is intermittent at first but quickly stabilizes and maintains throughout the entire test period. The arc currents in A and B are near 10% higher; C phase is more stable.

Fig. 15a: 25mm Gap, 4.1kA, 208V and copper bus bars.

Currents were always imbalanced as discussed in [4]. At the lower fault currents, intermittent currents were sometimes observed on A or C phase. See Fig. 15a for example. To properly assess overcurrent protective device performance, it may be necessary to predict B phase and average arc fault current.

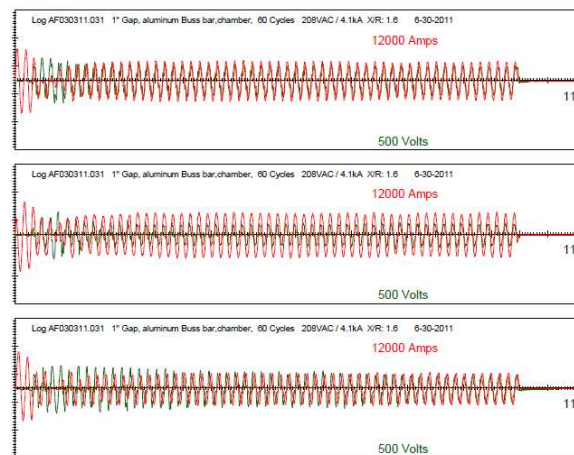
Fig. 15b. 25mm Gap, 4.1kA, 208V and aluminum bus bars.

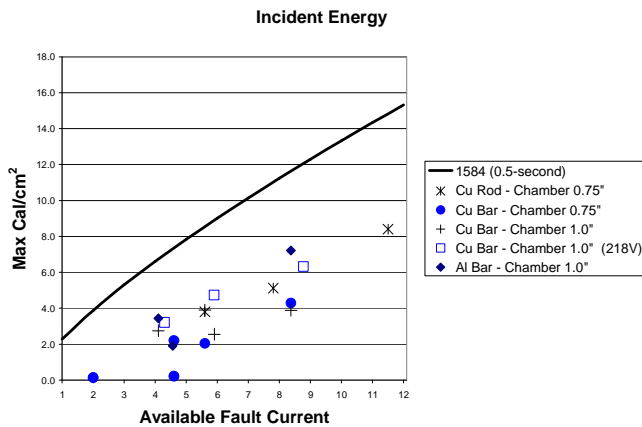
For all chamber configuration tests, the incident energy was less than predicted by the IEEE 1584 equations. Results are shown in Fig. 16. Where arcs were sustained, tests with the standard barrier, had measured incident energy closest to the IEEE 1584 predictions. Fig. 17 highlights a few cases where incident energy was higher than IEEE 1584 predictions.

Fig. 16. Plot of incident energy normalized to 30 cycles.

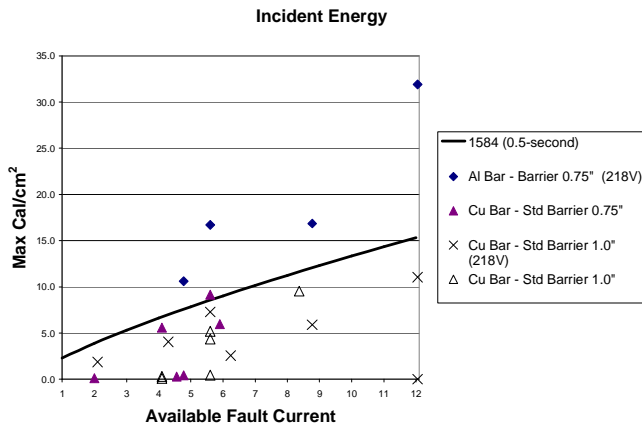
Fig. 17 Plot of incident energy normalized to 30 cycles.

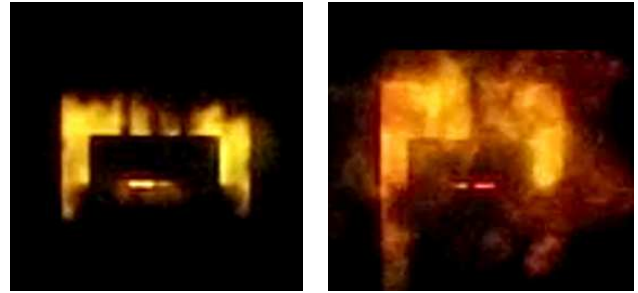
Fig. 18. Front view photos from chamber test.

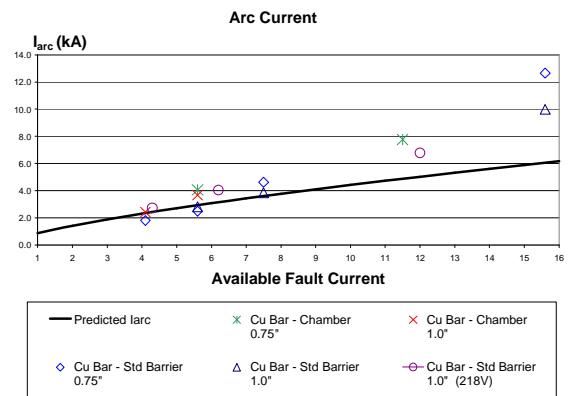
For all tests above 7.6kA, the measured arc current of B phase exceeded that predicted by the IEEE 1584 equations. However, below this level some configurations had arcing currents lower than predictions. Fig. 19 shows the average current after any re-strike.

Fig. 19. B-Phase arc current plotted versus IEEE 1584 predictions.

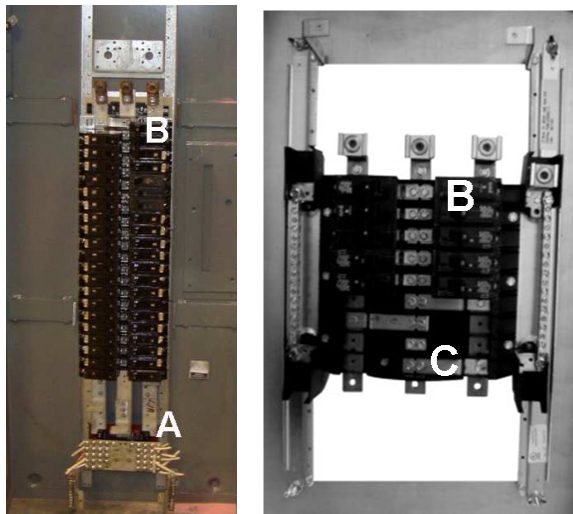
The authors evaluated three 250V panels to determine what locations within the panel were most likely to sustain arcs at low fault currents and which were most likely to create outward plasma flows. Fig. 20 highlights what are believed to be different electrode configurations within typical panels. The area labeled A would be similar to the barrier test configuration. Area B behind the circuit breakers would be like the chamber configuration with respect to ionization between electrodes. The feed through lugs near C on the panel in the right photo might be similar to the vertical open tip configuration.

Fig. 20. Multiple electrode configurations in panels

An arc was initiated above position B in the panel of Fig. 20. The test circuit was set at 250V and I_{BF} of 6.5kA. Spacing between the aluminum bus bars of this panel was 19mm. The arc was electromagnetically driven downward to a location behind the circuit breakers. Results are shown in Fig. 21 and Fig. 22. Note the amount of burning aluminum that was ejected. As shown in the trace, the arc self-extinguished and re-struck 18 cycles later. This trace closely resembles results shown in other figures for a chamber configuration test. The arc burned for a total of 1.6 seconds and appears stable at the end of the 2 second test period when the station breaker opened the circuit. The measured incident energy was 15.7 cal/cm^2 at 457mm. The IEEE 1584 prediction for 2 seconds is 20.6 cal/cm^2 and 16.9 cal/cm^2 for 1.6 seconds.

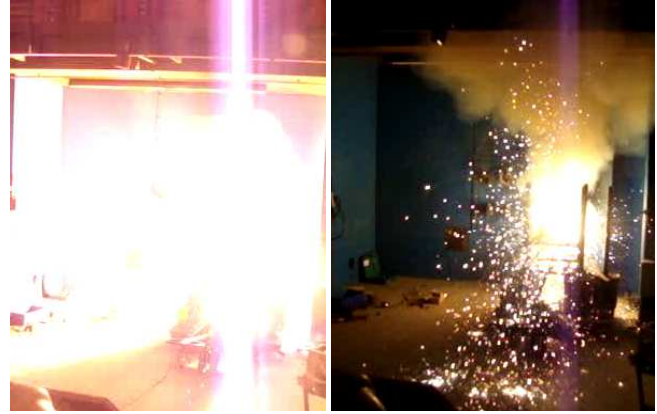
Fig. 21. Photos of panel with arc flash test at 250V and 6.5kA

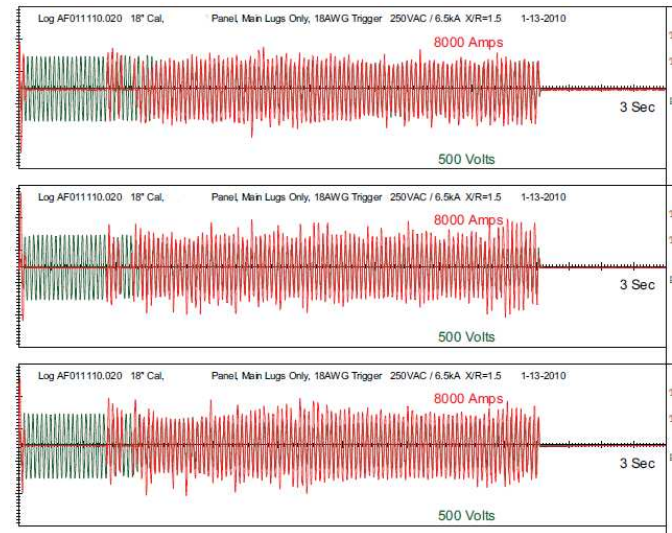
Fig. 22. Traces from Panel arc flash test at 250V and 6.5kA
